AFRL-RX-TY-TR-2008-4572

ADVANCED SPALL REPAIR METHODS AND EQUIPMENT

**Michael I. Hammons
Air Force Research Laboratory**

FEBRUARY 2009

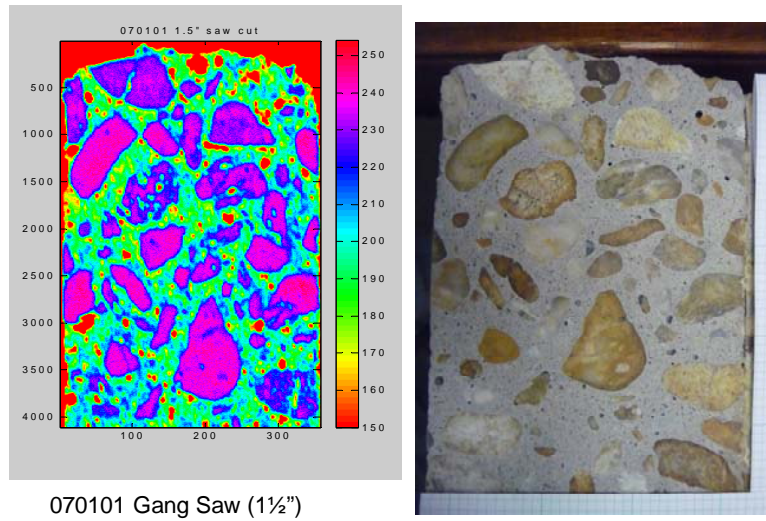
Figure 42. Images of Core from Gang Saw (1½-inch Spacing).

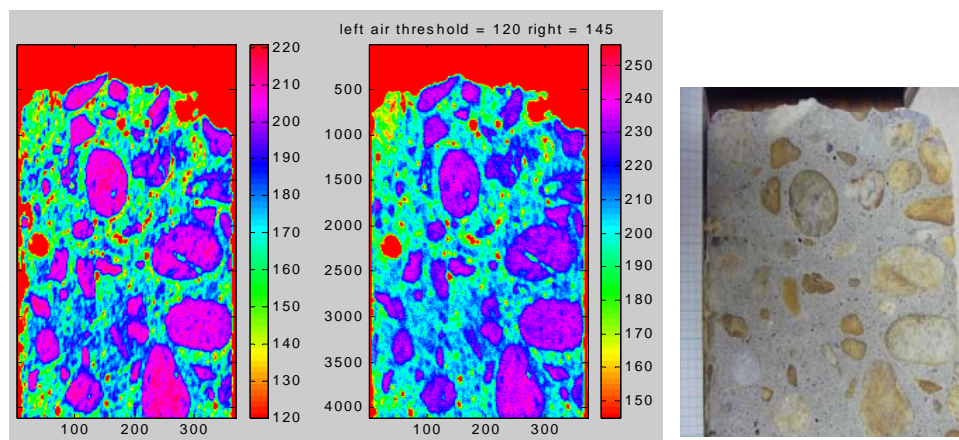
Figure 43. Images of Core from Gang Saw (3/4-inch Spacing).

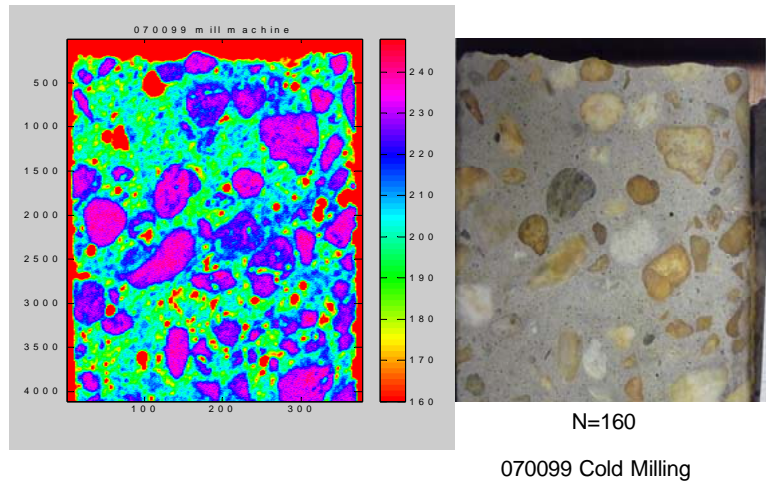
Figure 44. Images of Core from Cold Planer.

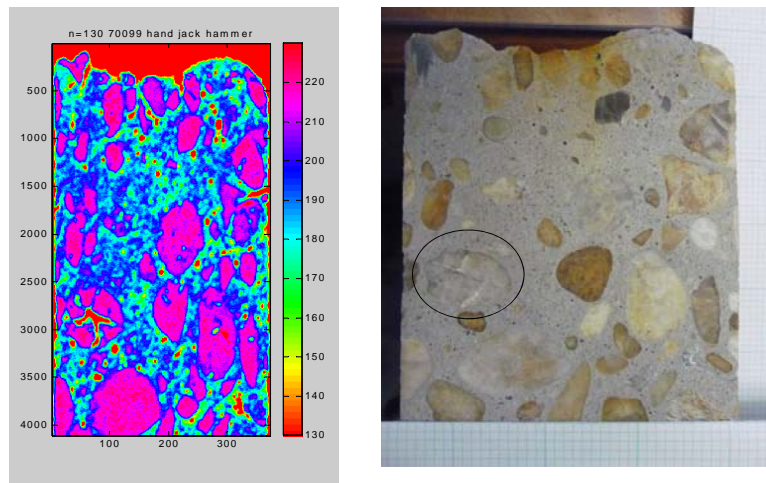
Figure 45. Images of Core from Jackhammer.

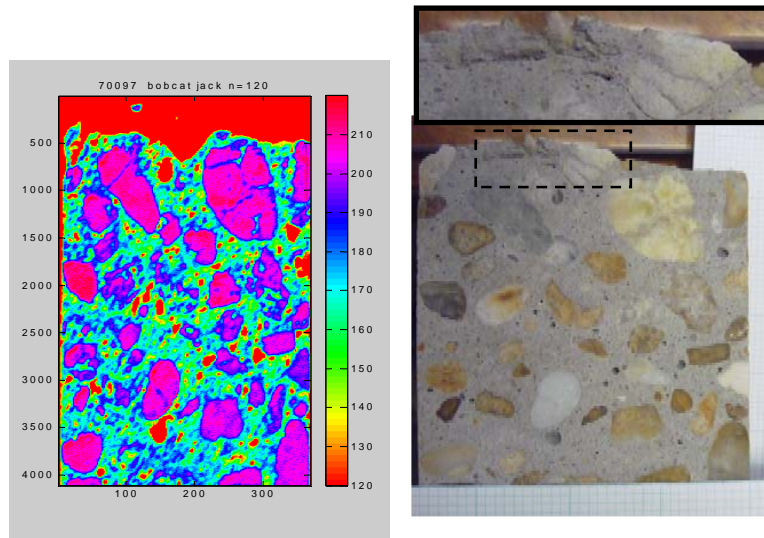
Figure 46. Images of Core from Hydraulic Breaker.

From an examination of these data, only the hydraulic breaker produced significant subsurface damage of the rock or paste at depths of up to ½ inch.
